# GEOTECHNICKÝ MONITORING V PRŮBĚHU HLOUBENÍ JAM A RAŽBY TUNELU DEBOREČ NA 4. ŽELEZNIČNÍM KORIDORU

## GEOTECHNICAL MONITORING DURING THE COURSE OF EXCAVATION OF PORTAL PITS AND DRIVING THE DEBOREČ TUNNEL ON RAILWAY CORRIDOR NO. 4

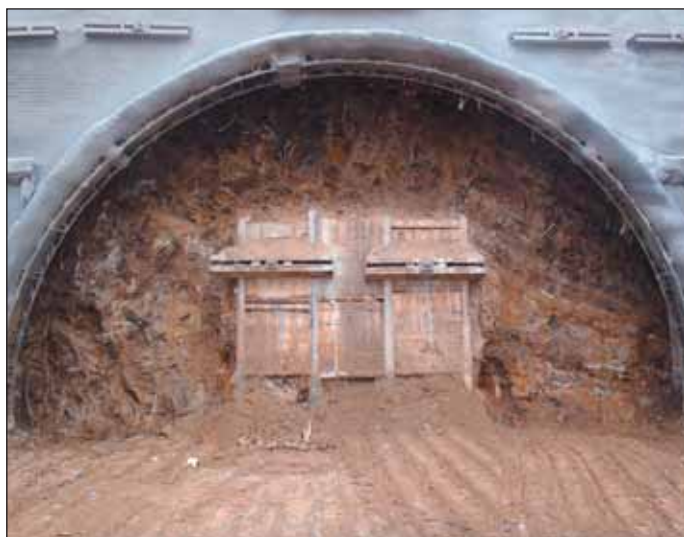
**Obr. 3 Čelba v TM 49,4 – výjezdový portál, zahajovací čelba ražené části tunelu**  
**Fig. 3 Excavation face at TM 49.4 – exit portal, opening excavation face of the mined tunnel part**

The tunnel is driven conventionally using the NATM. The excavation so far (as of 9<sup>th</sup> May 2019 the excavation face is at TM 123) encountered completely to moderately weathered, heavily fractured rock. It was disintegrated mechanically. Deeper in the massif, application of the drill and blast method is expected, with mechanical scaling of the excavation surface. The tunnel excavation sequence is horizontal, consisting of top heading, bench and bottom. In the longitudinal direction, the distance between faces of individual partial excavations depends on the geological conditions encountered and is determined by the excavation support class. The tunnel excavation proceeds uphill toward the entrance portal. A photo of the excavation commencement is in Fig. 3. Remains of the soldier pile and lagging wall which were left at the initial excavation rounds to stabilise the excavation face are visible in the photo in the space of the top heading.

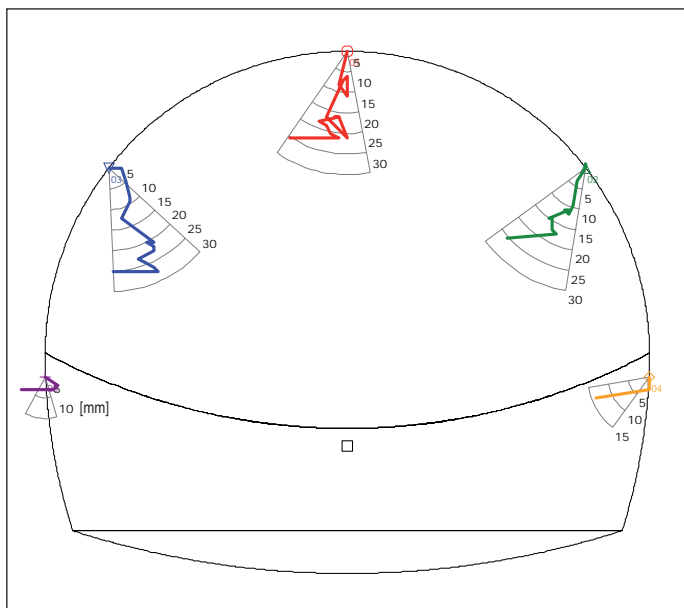
Obr. 4 Konvergenční profil v TM 68  
Fig. 4 Convergence profile at TM 68

An example of an output of the convergence profile from TM 68 is presented in Fig. 4; a graph of the settlement of the extensometer located above the tunnel centre line at TM 59.5 is presented in Fig. 5.

Příklad výstupu konvergenčního profilu z TM 68 je zpracován na obr. 4, graf sedání extenzometru situovaného nad osou tunelu v TM 59,5 je zpracován na obr. 5.

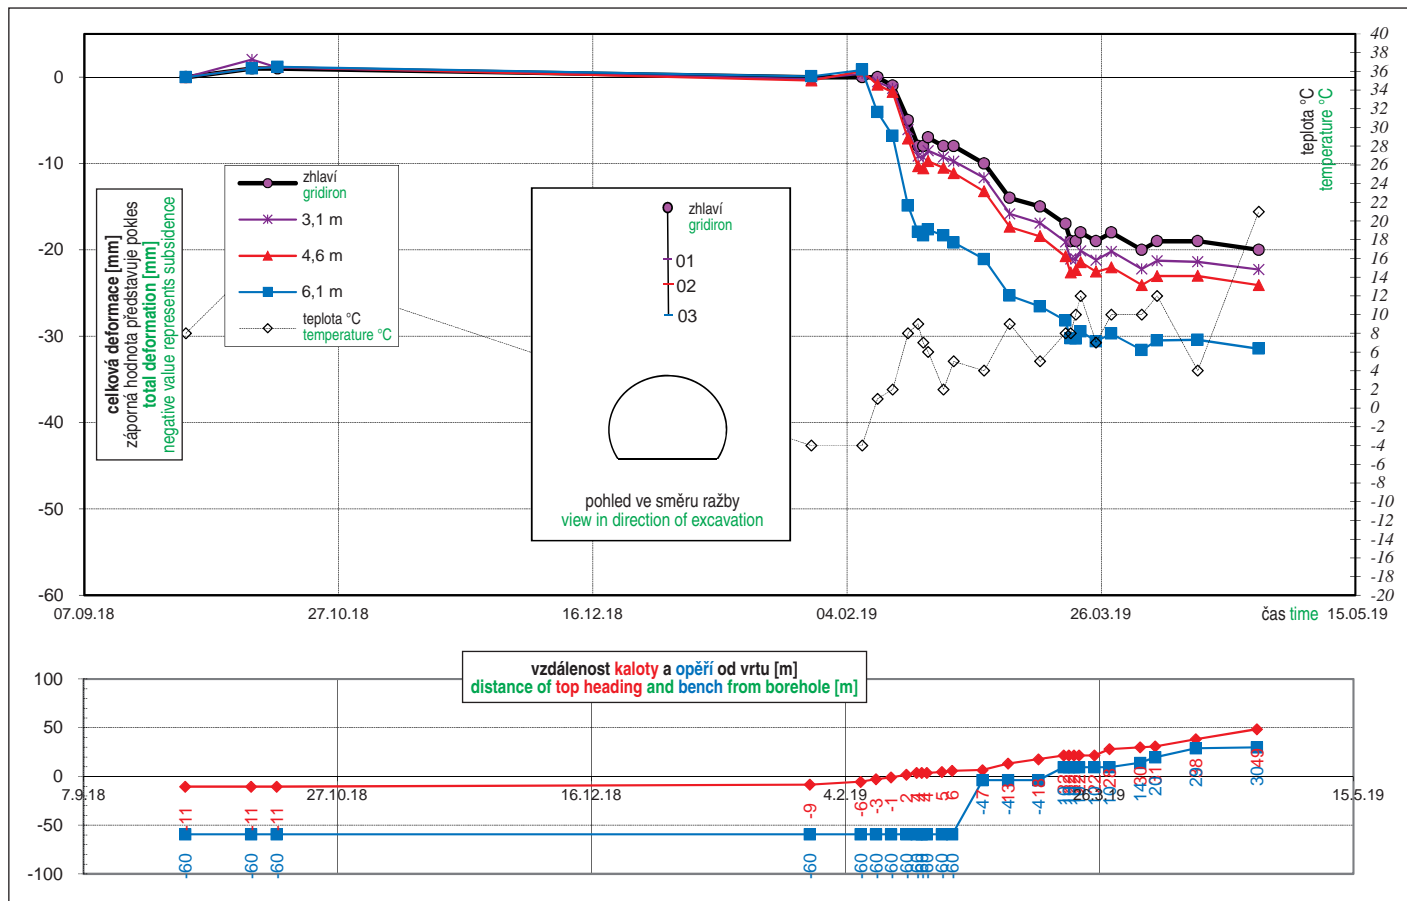
Obr. 5 Sedání extenzometru situovaného nad osou tunelu v TM 59,5  
Fig. 5 Settlement of extensometer located on the tunnel centre line at TM 59.5

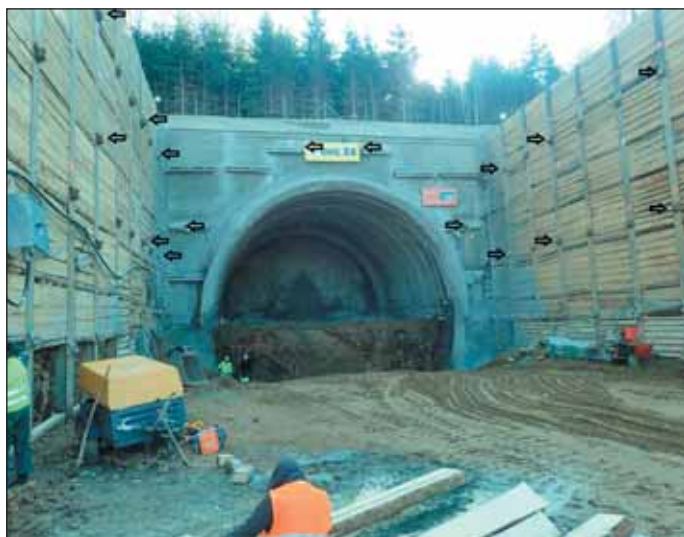
**Obr. 7** Pohled na výjezdový portál s osazenými 3D geodetickými body a dynamometry

**Fig. 7** A view of exit portal with the 3D survey points and dynamometers installed

A system of monitoring of movement of the walls is designed for the entrance and exit construction pits. The total of 40 pieces of 3D survey points are installed on each portal. Two inclinometers and one inclinometer are installed on the entrance portal and the exit portal, respectively. A view of the exit portal with 3D survey points and dynamometers is presented in Fig. 7.

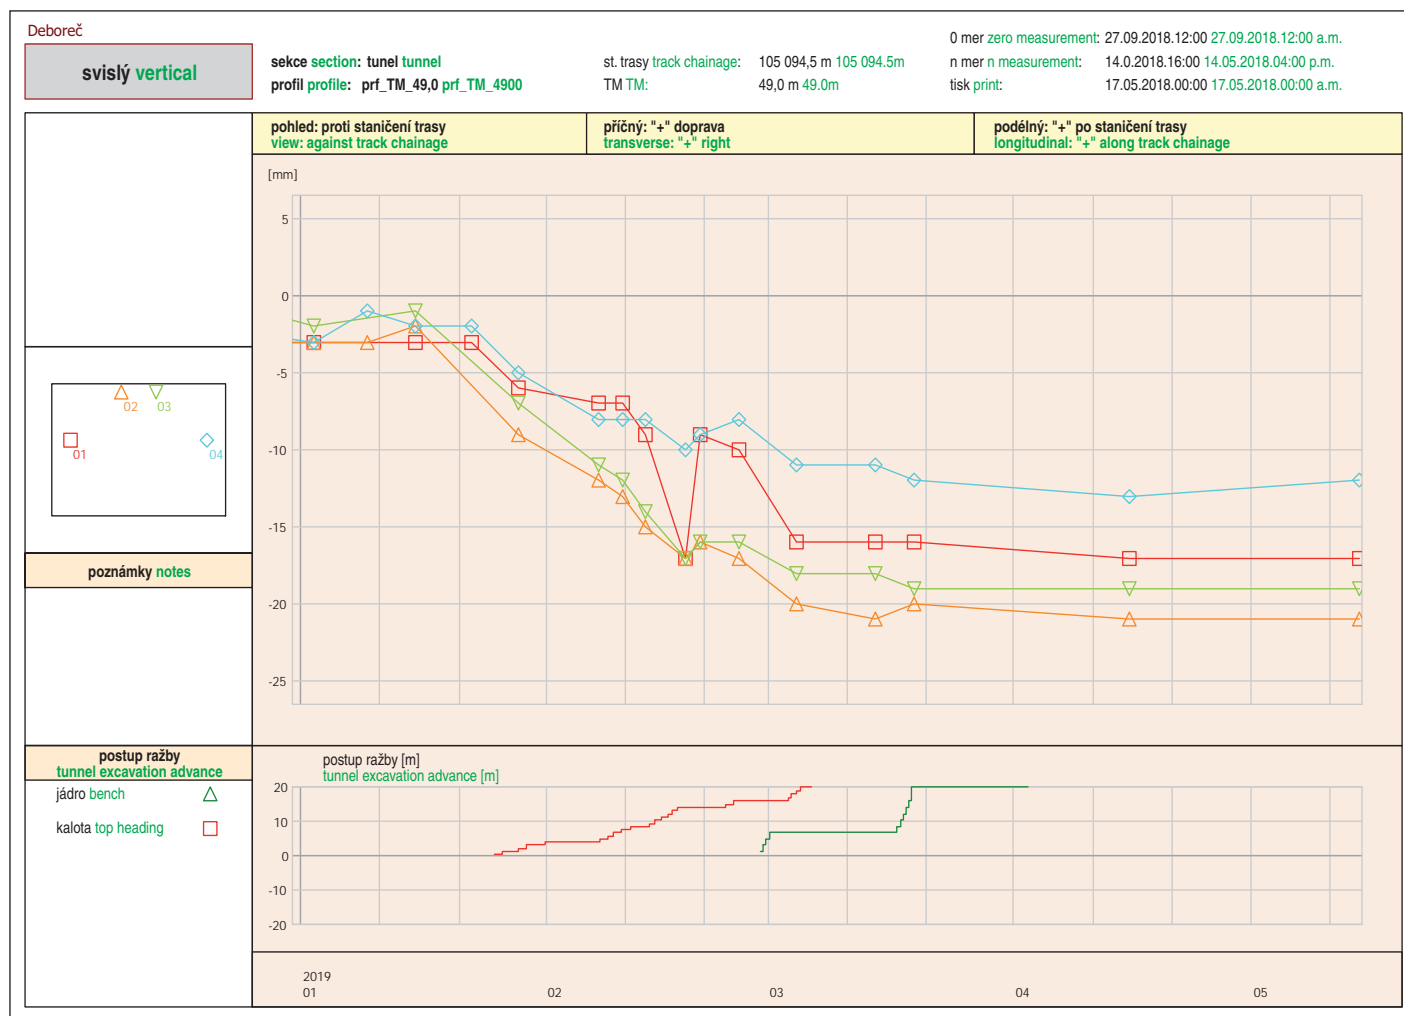
Obr. 8 Graf sedání portálové stěny  
Fig. 8 Graph of portal wall settlement

The values of individual components of deformations (longitudinal, transverse, vertical) measured on side walls of the braced pit for the exit portal reach up to 15mm; the first alert state set at 20mm of tilting out/pressing in/settling of the portal wall was not reached in that location. Inclinometer D IN 2 located above the south-western side wall exhibits only insignificant deformations not exceeding 2mm. Horizontal deformations (tilting out/pressing in up to 10mm) were measured on the survey points on the portal wall; settlement values reached up to 21mm, slightly exceeding the alert level. After closing the tunnel profile by invert in the portal area, deformations stabilised and no more grow. The graph of the portal wall settlement is presented in Fig. 8.

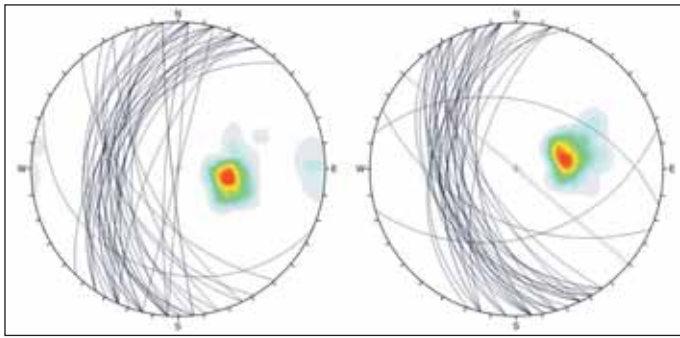
Obr. 10 Konturové diagramy pólů ploch foliace na výjezdovém portálu (vlevo, 50 měření) a předběžném 1. KHB (vpravo, 47 měření) tunelu Deboreč  
 Fig. 10 Contour diagrams of poles of foliation surfaces at the exit portal (left side, 50 measurements) and the preliminary QHB No. 1 (right side, 47 measurements) of the Deboreč tunnel

Tektonické porušení horninového masivu lze nejlépe ilustrovat pomocí konturových diagramů pólů ploch diskontinuit promítaných na spodní hemisféru Lambertova prostoru (zvolena „equal angle“ projekce), zde zpracovaných pro výjezdový portál tunelu Deboreč a předběžně stanovený 1. kvazihomogenní blok (dále pouze 1. KHB) tunelu Deboreč v TM 49,0–94,0.

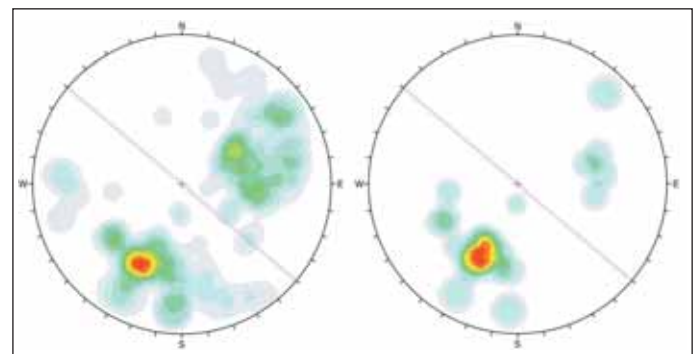
Obr. 12 Konturové diagramy pólů ploch interpretovaných jako zlomové zóny (vlevo, 94 měření) a žíly (vpravo, 22 měření) v rámci předběžného 1. KHB tunelu Deboreč

The final pair of contour diagrams in Fig. 12 displays poles of the surfaces interpreted as fault zones (left side, 94 measures) and veins (right side, 22 measurements) within the framework of the preliminary QHB No. 1 of the Deboreč tunnel. The correlation between the directions of faults and veins is evident at first sight. With high probability, the veins used the pre-existing preference routes for their intrusions. The direction 15–40°/50–70° common for both diagrams is most distinct. The direction of faults 225–280°/40–55° approaches the direction of foliation (see Fig. 10, right side). It is only little steeper, indicating that the orientation of some faults, at least in the part of its courses, approximately copies the orientation of foliation, again in the meaning of the predisposition. Even here the veins are locally an accompanying element of fault zones. The fault zones are relatively well localised, planar, usually decimetres wide, exceptionally even over 1m. Within the framework of the zone, the rock is crushed, relatively more weathered, generally with lower strength, in extreme cases with the character of up to sandy-clayey soil. The main direction of fault zones approximates the direction of the centre line of the tunnel. The gradual onset and relatively long presence of the fault zones within the tunnel cross-section, as well as the mostly unfavourable to very unfavourable orientation in the meaning of the RMR rating (in the cases of steeper ones), follow from the main directions of the fault zones approaching the direction of the tunnel centre line.
